**REPORT**  
**Dielectric and Mechanical Tests on Aged E/Bus Support Cover and E/Bushing Covers**

**Purpose of Tests:** To determine if E/Bus and E/Support covers meet the design requirements of IEEE 1656 after, respectively, 18 and 14 years of service, as tested in the “as received condition”.

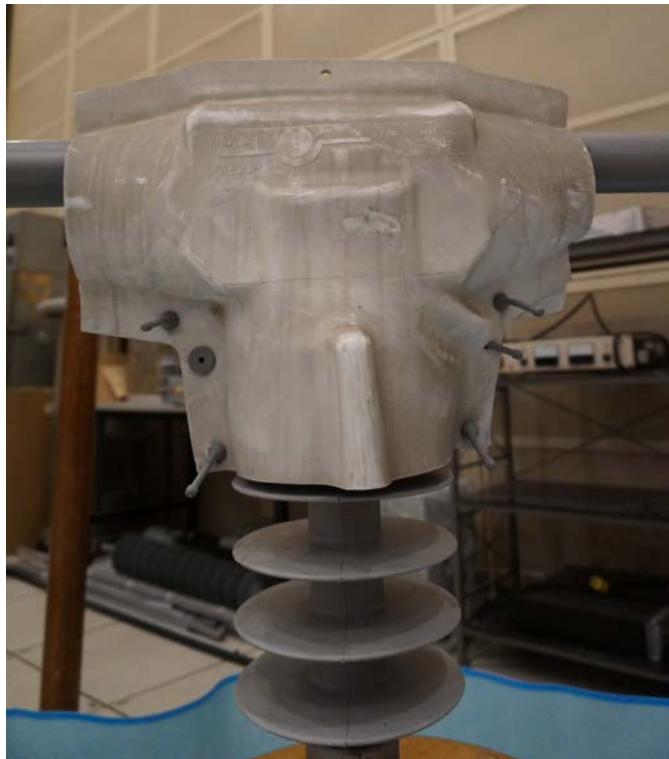
- 1. E/Bus Support Cover; in service for 18 years.**

**E/Bus Support Cover**

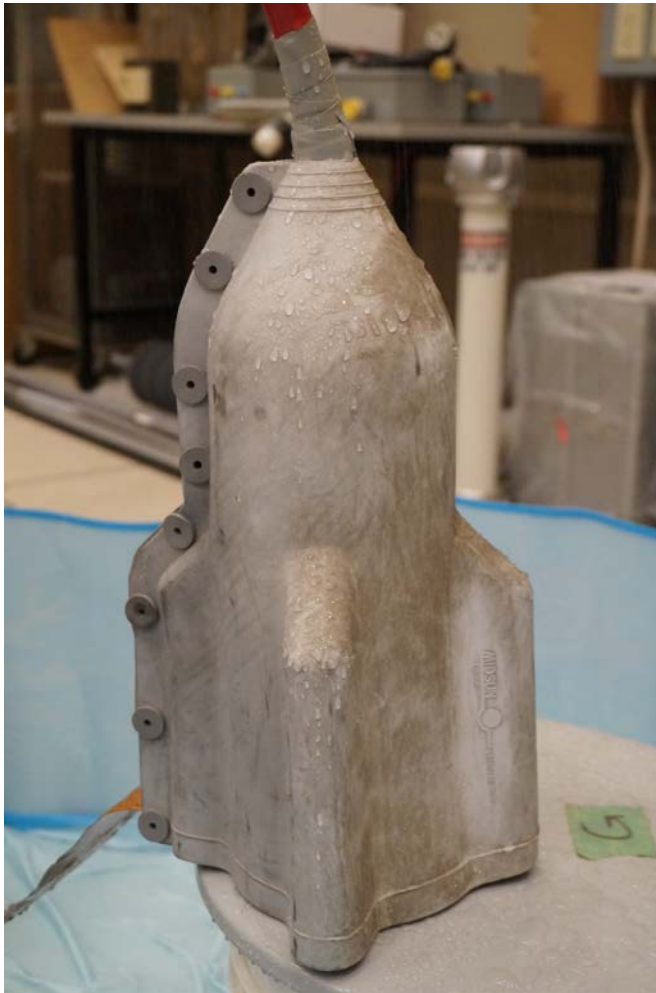
## 2. E/Bushing Cover-Large; in service for 14 years.

**E/Bushing Cover-Large**

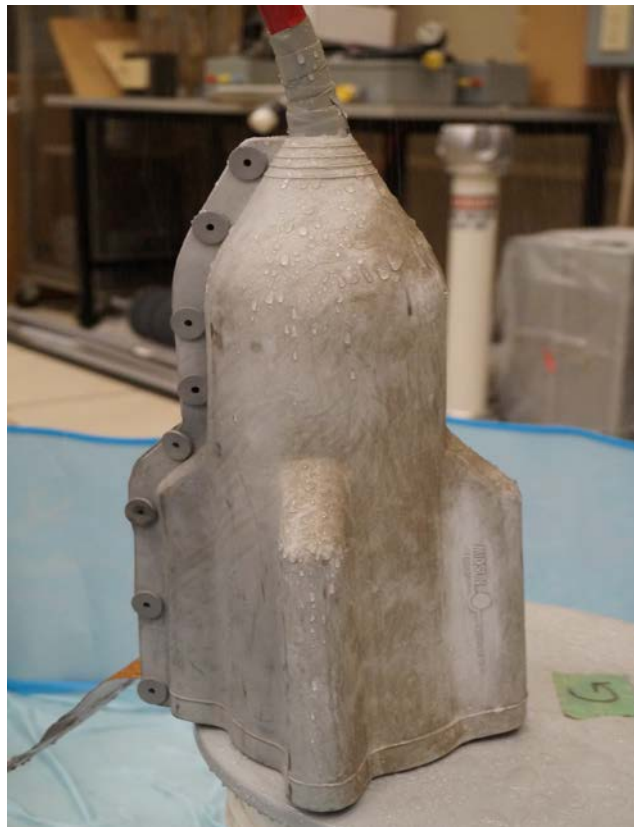
**E/Bushing-Large Cover applied to a 34.5 kV transformer bushing.**

The E/Bushing-Large Cover was applied to a 34.5 kV transformer bushing and tested at 26 kV (phase-to-ground) (120% of the phase-to-ground rated voltage).

**Remarks:** No puncture or flashover occurred.

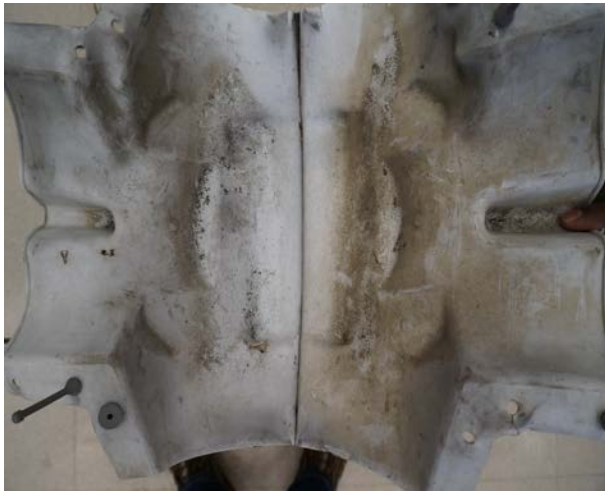
A 34.5 kV polymer station post was tested for wet power frequency flashover, first without the E/Bus Support cover and then with the cover installed. For the cover test, a 1 inch bus conductor, with E/Insulation was applied to the bus at each cover exit. Three flashovers were obtained and the average for the uncovered post insulator was 120 kV; but somewhat lower at 87 kV with the cover installed. The flashovers took place along the post and on the inside of the E/Bus Support cover. The wet contamination on the inside of the E/Bus Support cover contributed to the lower wet flashover. However, the insulation margin is still quite high.

**Contamination on inside of E/Bus Support cover.**

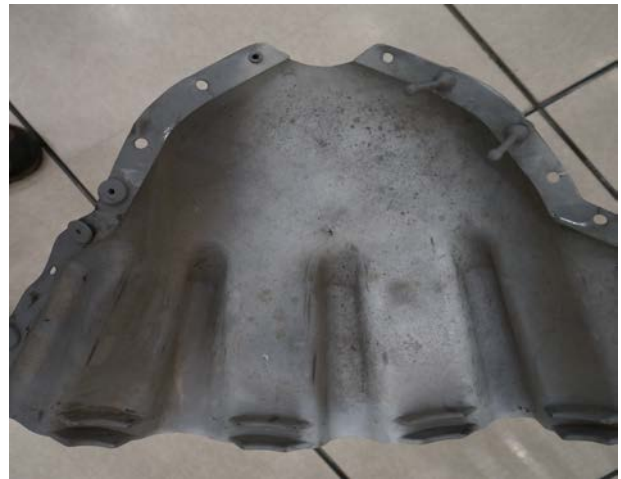
Similarity, a 34.5 kV transformer bushing was tested for wet power frequency flashover, first without the E/Bushing-Large cover and repeated with the cover installed. The average of three flashovers of the bushing was 93 kV and with the bushing cover applied, it was 60 kV. Once again, the flashovers took place along the inside of the cover and the wet contamination on the inside of the cover contributed to the lower wet flashover. As with the station post test, the insulation margin was high.

**Contamination on inside of E/Bushing cover.**
